# Manhole Inspection Summary

Manhole # **S13GG\_044MH**

**Location** Address: **2761 BAKER ST** Cross Street: **DUKELAND ST**

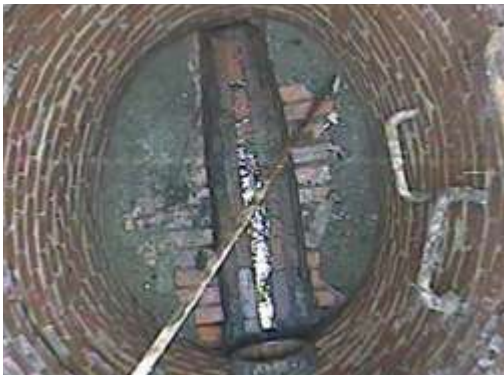
Defect 1

**Steps** Count: **5** Missing: **0** ☒ **Corroded**

CORRODED STEPS

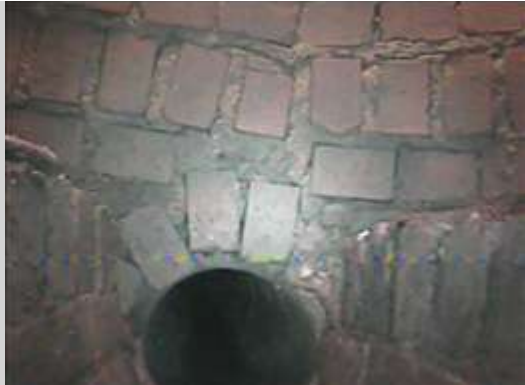
12 O'Clock Outflow

8 in. Circular Gravity Sewer  
Pipe Out @ 12 O'Clock

Pipe Material: **Clay** ☐ Pipe Lined

Invert Depth: **10.60** (ft.) Flow Characteristics: **Slow**

Deposits: ☒ None ☐ Mud ☐ Sludge ☐ Debris ☐ Grease

Infiltration: **None** Pipe Seal Cond: **Sound**

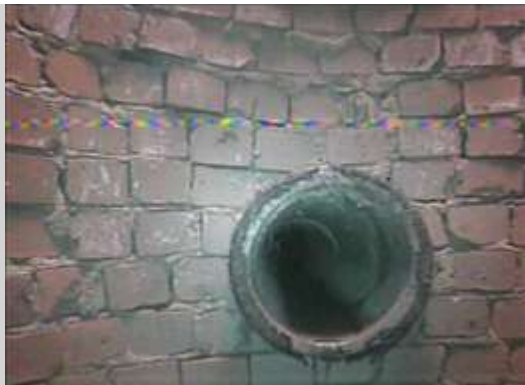
6 O'Clock Inflow

8 in. Circular Gravity Sewer  
Pipe In @ 6 O'Clock

Pipe Material: **Clay** ☐ Pipe Lined

Invert Depth: **9.32** (ft.) Flow Characteristics: **Slow**

Deposits: ☒ None ☐ Mud ☐ Sludge ☐ Debris ☐ Grease

Infiltration: **None** Pipe Seal Cond: **Sound**
